# Your basin or sink tap flanges won't screw all the way down?

## **EZYFIX Trouble-shooter:**

This guide provides a solution that can be used on both modern and classic styled hob type taps.

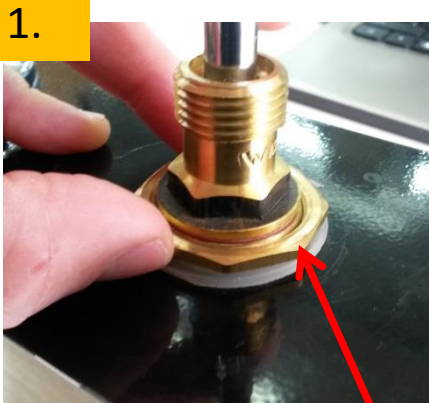
Top and bottom  
body locknuts

1. Remove all buttons, handles and flanges and loosen body locknut above the basin.
2. Loosen the body locknut below the basin.
3. Push down on the basin body so it moves the distance required to remove the gap beneath the flange.
4. Re-tighten the top body locknut and re-dress the tap.
